**NATIONAL ASSOCIATION SUPPLY CO-OPERATIVE, INC.**  
2031 Reiser Ave SE • New Philadelphia, Ohio 44663  
800-321-3396 • **FAX 800-992-6679** • [www.nascoop.com](http://www.nascoop.com)

## ...Magnet chain installation instructions:

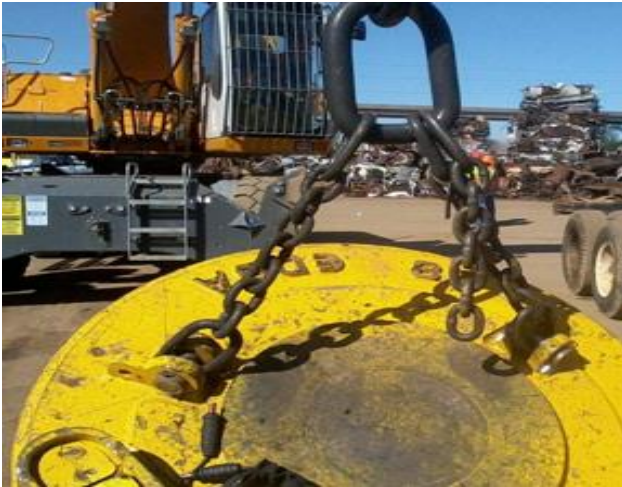
PICTURE 1

See the following examples of an **improperly** installed chain: **Picture #1**: The chain legs are twisted; you can see it best on the left leg. Also the chain was hooked on the magnet correctly but the master link was hooked up at a 90 degree angle to the material handlers yoke causing binding. Being attached to a yoke style hanger limits the ability to self-correct like a swivel hook allows. **Picture #2**: A close-up of the wear on the connecting link is shown. The right leg is twisted causing binding, notice the fourth body link compared to the orientation of the second link above it. They do not line up in a straight line.
