NATIONAL ASSOCIATION SUPPLY CO-OPERATIVE, INC.
2031 Reiser Ave SE • New Philadelphia, Ohio 44663
800-321-3396 • **FAX 800-992-6679** • www.nascoop.com

...Magnet chain installation instructions:

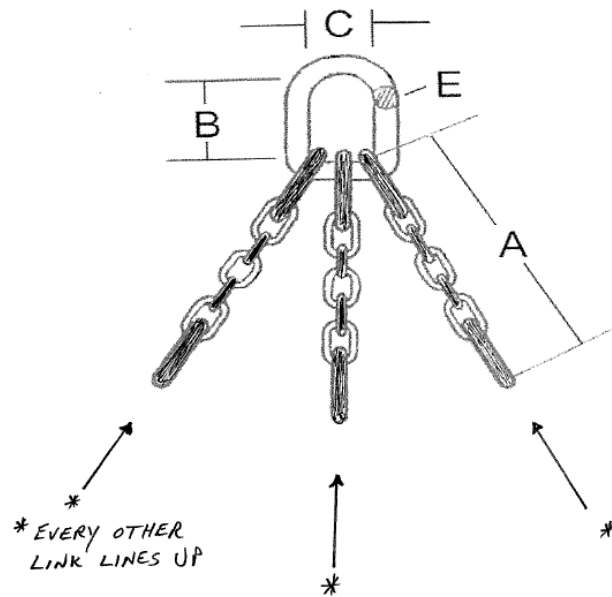
DRAWING 1

7. Lift the magnet from the ground, it should hang level, if it is dipping to one side look to see if the opposite side leg is twisted or kinked.
8. The chain links will line up straight every other link and not curl or twist when properly installed (**see drawing #1**). The chain will not twist on its own if hung from the crane properly.
